**SAS Superstructure**

Daily Diary Report by Bid Item

Diary #: 056 Const Calendar Day: 254 Date: 20-May-2010 Thursday

**04-0120F4
04-SF-80-13.2/13.9
Self-Anchored
Suspension Bridge****Weather**

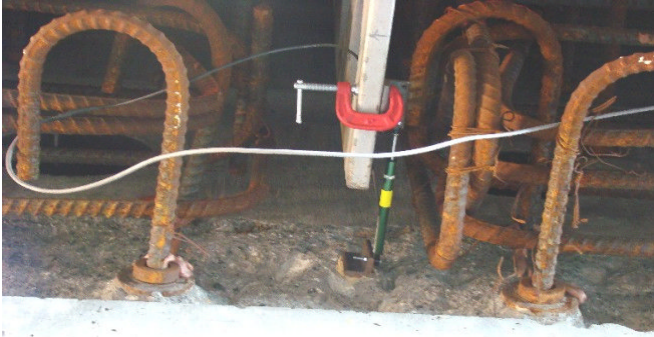
Monitoring device on at the bottom in the middle of OBG lift 1W. It is unknown if the thermal expansion of this device was factored into measurements.

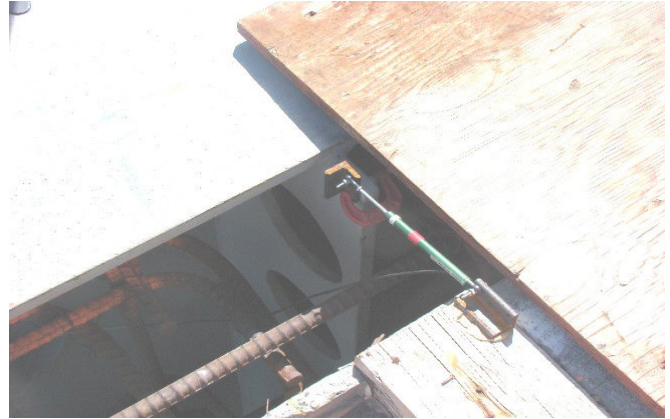
Monitoring device placed by ABF at the north stiffener plate of OBG lift 1W.
